Product/Process Change Notice - PCN 18_0190 Rev. -

PCN Title: ADUCM310/320/320i/322: Metal Edit

Publication Date: 11-Dec-2018

ADuCM320/ ADuCM320i ADuCM322/ADuCM322i PCN

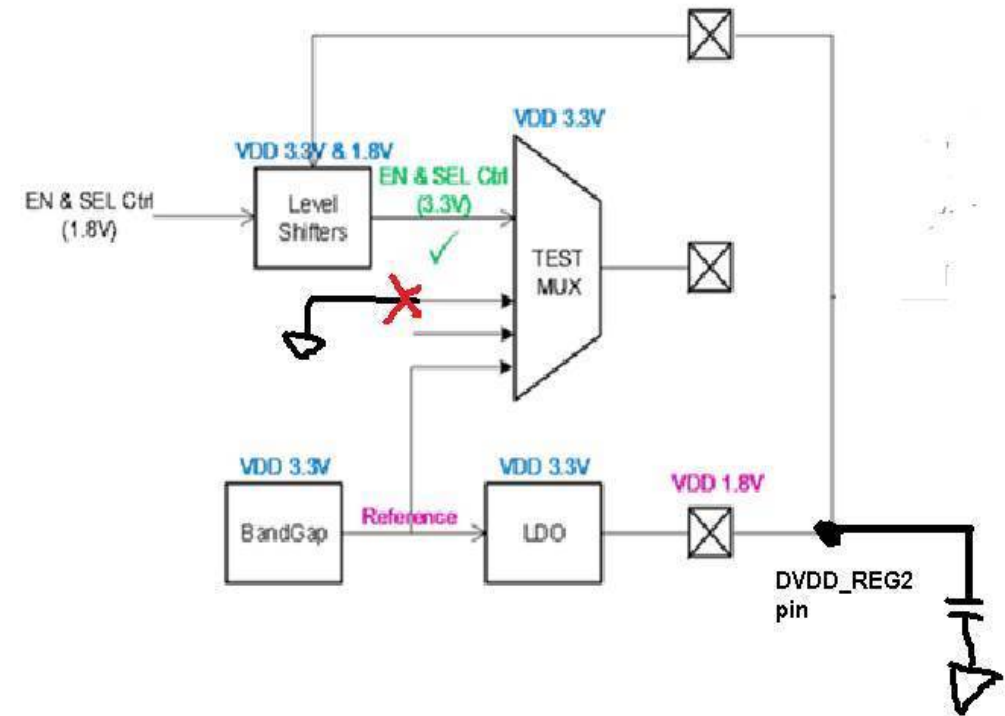
- ▶ A small number of ADuCM32x devices had a Power-up issue
 - Low ppm failure (<10ppm)
 - Failures mainly at low temperatures (<0C) and >50C
 - Failing devices susceptible to Power up problems especially with slow VDD ramp rates
- ▶ Issue identified with digital die 1.8V regulator (LDO)
 - Test screen for old silicon revision identified to provide interim cover
 - But not guaranteed to screen all weak parts.
- ▶ Silicon edit identified to fully fix the issue
 - All revisions of ADuCM310/ADuCM32x fixed
 - Characterization is complete
- ▶ ADI ready to release new revision of ADuCM310/ADuCM32x to production
 - Future shipments will use revised digital die with silicon fix for this issue.

- ▶ Cut a single track to disconnect a grounded input to a Test Mux – see the red “x” below to indicate the location.
- ▶ When the 3.3V DVDD power supply is rising from 0V towards the Power-On reset threshold voltage, the enable and select signals to the Test MUX shown below are undefined.
- ▶ In some corner cases on previous silicon, this sometimes resulted in the output of the Bandgap being shorted to the GND input of the MUX.
- ▶ This meant that the digital LDO did not get a valid bandgap voltage and did not power up correctly.
- ▶ The digital LDO output is 1.8V and is required for the Cortex-M3 and other digital peripherals to operate properly.
- ▶ In the failing cases, this 1.8V rail did not come up properly and led to the Cortex-M3 never executing user code

The silicon edit involved cutting a single track to disconnect a grounded input to a Test Mux to help power-on Reset conditions.

With the silicon edit, the case described above can no longer occur.
