1 Products affected

2 Type of change

0909 Multiple IEC Appliance Outlets F					
Release date:	Released by:				
24.5.2011	SHO				1 von 2

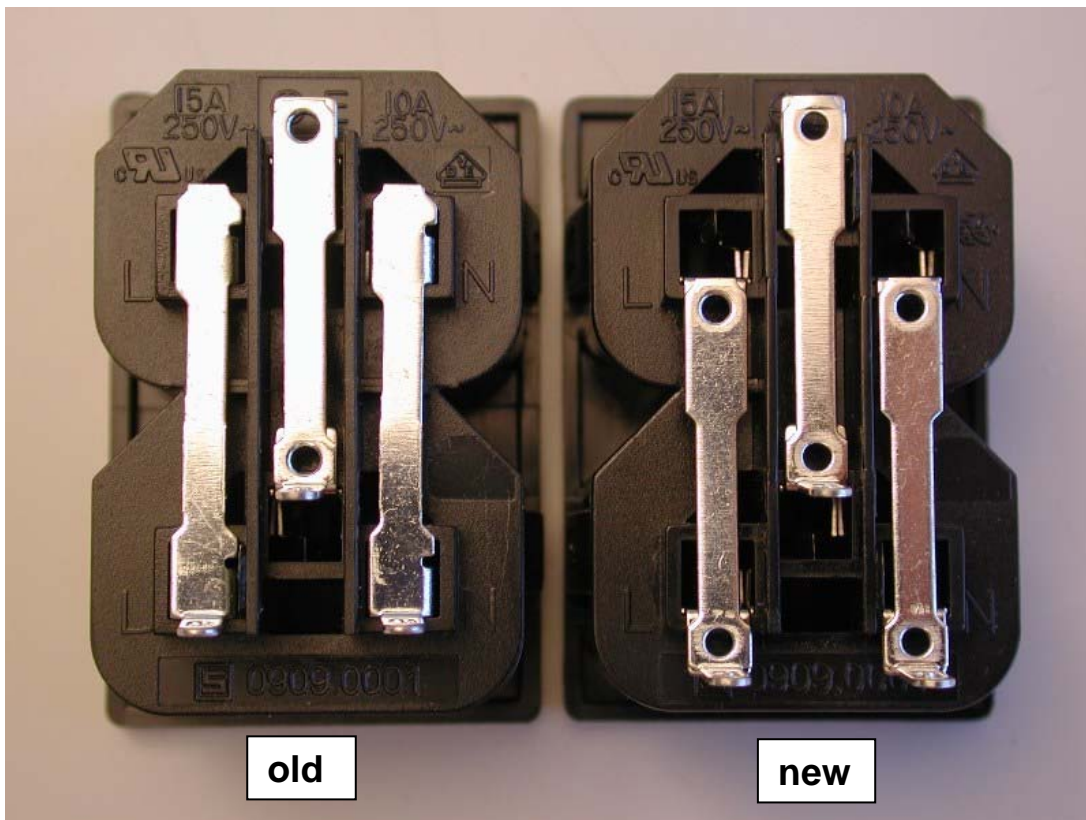
The old version had only the earth bar riveted to the outlet contacts - L/N bars and contacts were made of one piece. The new version has L/N/E riveted. (The holes are the riveting joints)
