HIROSE ELECTRIC CO., LTD.
 2-6-3 Nakagawa Chuoh, Tsuzuki-ku, Yokohama, JAPAN

Product Change Notification

■Product list PCN2022-12_Report on improvement of the shield board plating in our product DF40GB series

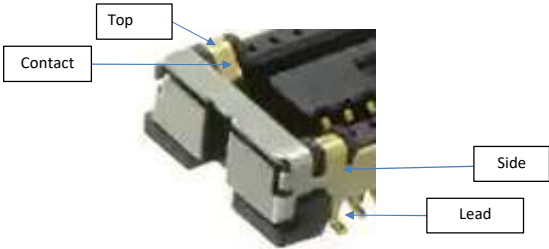
1	Products affected	DF40GB series *Please refer to the attachment for detailed product names.
2	Replacement product	There is no change in product code and product name.
3	Classification of change	Plating Improvement
4	Changes	<p>The gold plating appearance of the shield board will be changed. The current shield board plating technology applies gold plating on the lead, side, top and contact area of the shield in a straight line. As a result, there is a risk that solder will rise to the contact point on the top surface in case of the large amount of solder or the different reflow conditions from our recommendations. This time, we have established a processing technology that applies gold plating only to the lead and contact area, so we will implement this improvement to suppress the spread and reduce the risk of solder rise. Although there is a change in the appearance of the shield board, there is no change in product performance.</p>

<p>Side (After Change)</p> </div> </div> <p>From the comparison photos before and after the change, it can be seen that there is gold plating spread on the side and top of the shield board before the change, and thus cause solder rise on the side after mounting. The improved product has suppressed gold plating spread and solder rise after mounting.</p>

5	Reason for change	To reduce the risk of solder rise
6	Schedule of change	We are planning to switch to the improved product from June 2023 onwards.
