PRODUCT VERIFICATION REPORT

TEST RESULTS AND TECHNICAL DATA FOR THE LITTELFUSE 242 SERIES, HAZARDOUS AREA BARRIER NETWORK FUSE

January 21, 2020 (Revised May 08, 2020)

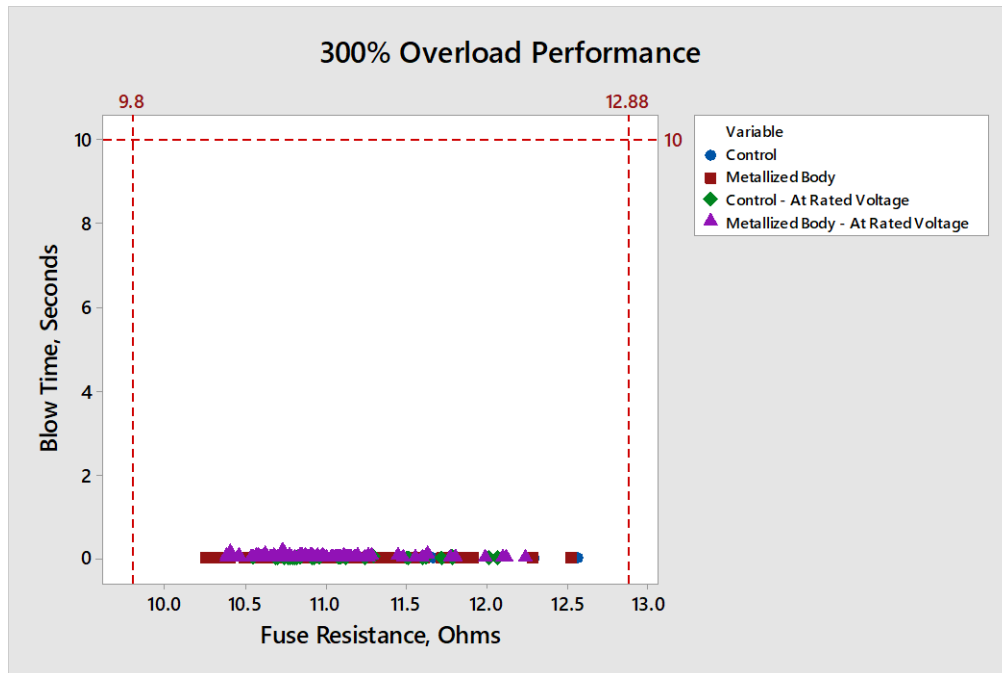
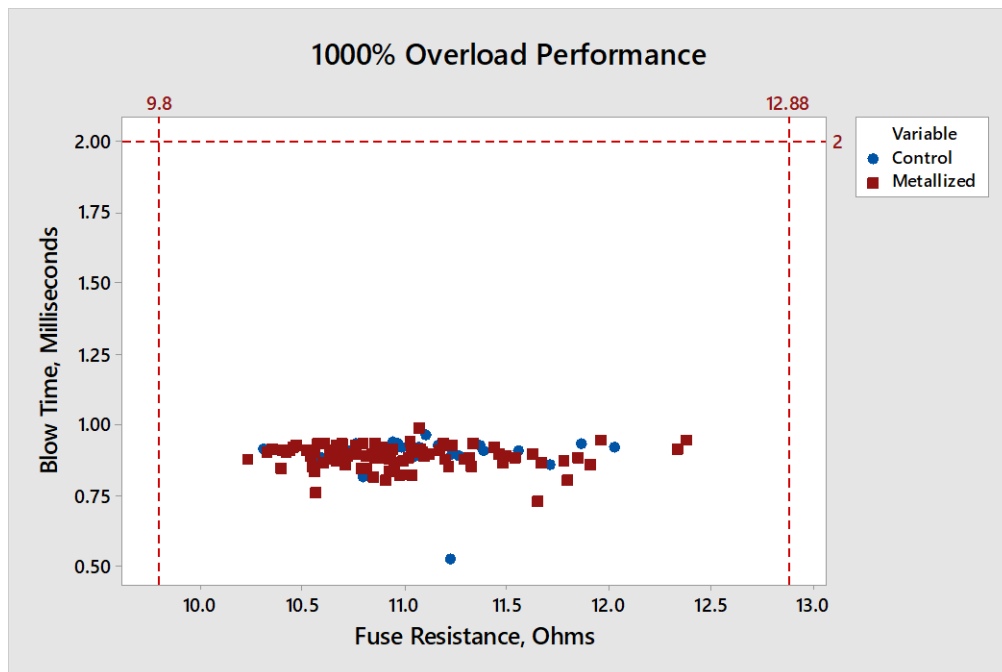
Figure 4. Scatterplot of Blow Time and Resistance (300% and 1000% Overload)

Fuses are required to operate within the following parameters for the overloads specified. 300% overload gate must open within 10 seconds. 1000% overload gate must open within 2 milliseconds.

Overload Test	Sample Size	300%In Overload			300%In Overload at Rated Voltage			1000%In Overload		
		10 seconds Max			10 seconds Max			2 milliseconds Max		
		Min	Ave	Max	Min	Ave	Max	Min	Ave	Max
Control Group	30	0.007	0.009	0.013	0.007	0.011	0.016	0.524	0.894	0.964
Metallized Body	90	0.006	0.008	0.014	0.008	0.018	0.143	0.726	0.885	0.984

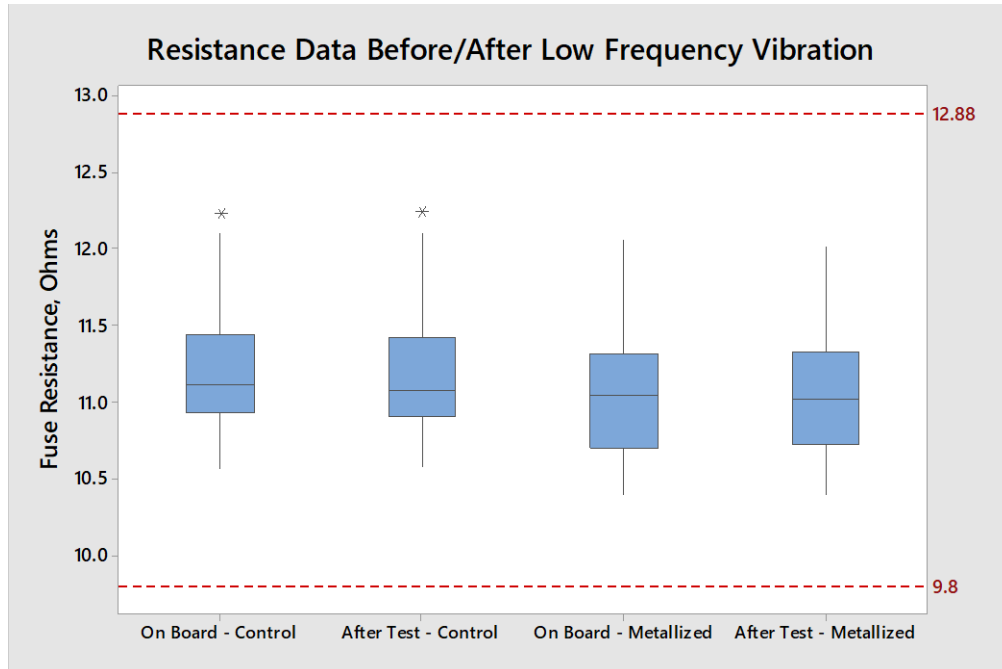
Figure 6. Boxplot of Fuse Resistance (Before & After Low Frequency Vibration)

Fuses were subjected to vibration in frequencies which would be usually encountered in field service. Test performed as per MIL-STD-202, Method 201. Frequency range used for the test is 10-55Hz, which is traversed back and forth in approximately 1 minute. Duration is 2 hours per axis which totals 6 hours of vibration. The test follows a simple harmonic motion with 0.03inch amplitude. The acceleration is not specified on the standard but is proportional to the specified amplitude and frequency. Max acceleration at 55hZ is less than 10G's (~9.3 G's).

Low Frequency Vibration Data	Sample Size	On Board Resistance (Before Low Frequency Vibration)			Fuse Resistance Before Post Test (After Low Frequency Vibration)			Post Life Test	Post Overload Test
		Min	Ave	Max	Min	Ave	Max		
Control Group	30	10.57	11.23	12.24	10.58	11.21	12.24	Passed	Passed
Metallized Body	90	10.39	11.07	12.06	10.39	11.06	12.02	Passed	Passed

There were no open fuses after post life test. All fuses on overload test opened within the specification limits. As noted above, resistance values (after low frequency vibration) were within specifications.

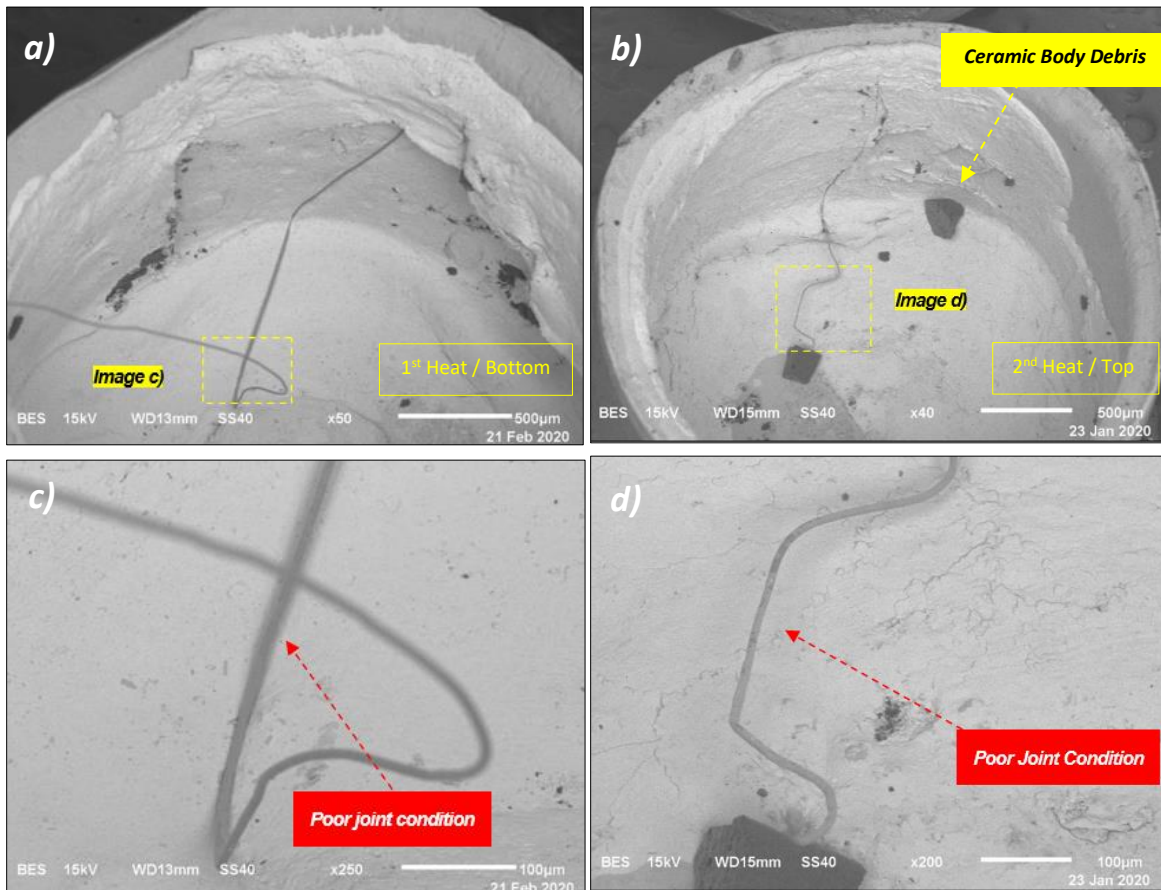
Figure 9. SEM Photos of Poor Joint Condition

The close-up photos (image c, d) below are samples of poor joint. Even if the wire is attached, there is very little contact between the wire and solder surface. In some cases, the wire will be easily removed during sample preparation and will show only shallow imprints as evidence of its original location.

For reference, both samples are non-metallized fuses. Location of close-up photos are noted on the low magnification photos.

Several samples were analyzed through SEM to further verify the solder joint condition. Refer to Appendix 4.1 (SEM Photos of Solder Joint).
