## PRODUCT CHANGE NOTIFICATION

**Product Identification:** Bel 0863, 0864, 0873 2x4, 2x6, 2x8 ICMs

**PCN Number:** PC2190135

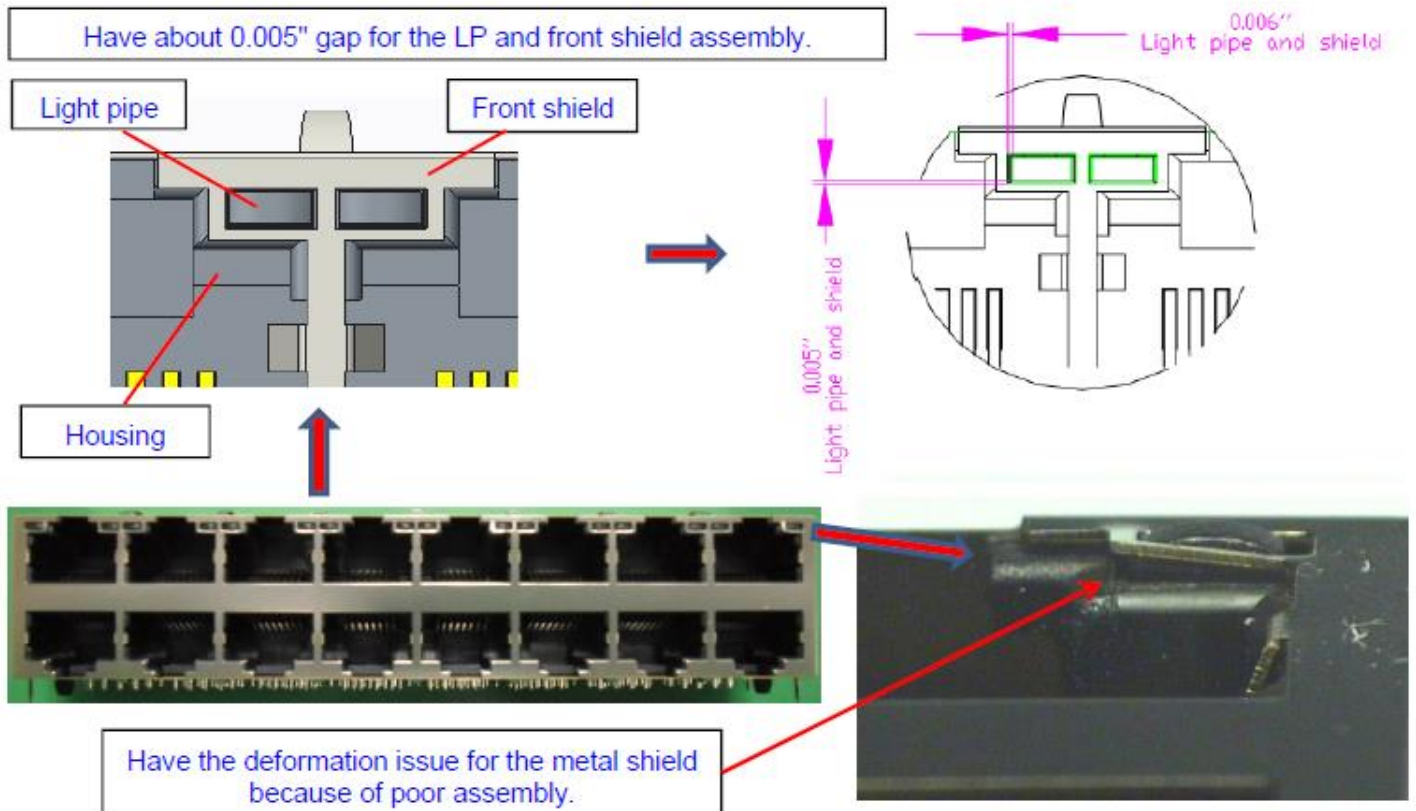
**Reason for Change (s):** In an effort to continually improve our product, Bel is pleased to announce a modification to the front shield of the 0863, 0864 and 0873 2xN ICMs in the specific area of the light-pipe and front shield. As shown below the gap between the light-pipe and shield is too small and can cause the shield to bend or become misaligned and create a snagging hazard. The solution is to remove the thin window frames from around the inside and bottom of the light-pipe.

**Description of the Change (s):** To resolve the assembly issue and deformation of the shield around the light-pipe, the thin, shield window frames around the inside and bottom of the light-pipe will be removed. By removing these thin metal pieces, the limited gap issue will be resolved and there will not be a concern for shield deformation. Please see the details below.

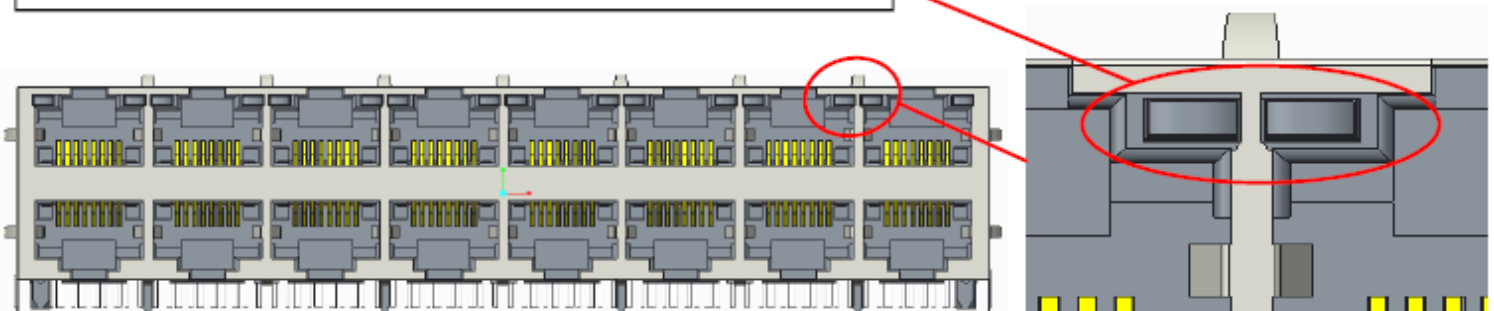
New finished goods: remove the LED window features.
